## GEOMETRY VARIATION OF BALLASTED RAILWAY TRACKS DUE TO WEATHER CONDITIONS

**Purpose.** Investigate and establish the relationship between track geometry measurements and weather conditions to determine the parameters that influence the lifetime of railway tracks' superstructure system. The study of ballasted beds of railway tracks is very important for operation and maintenance in case of main lines, industrial sidings and mine transport.

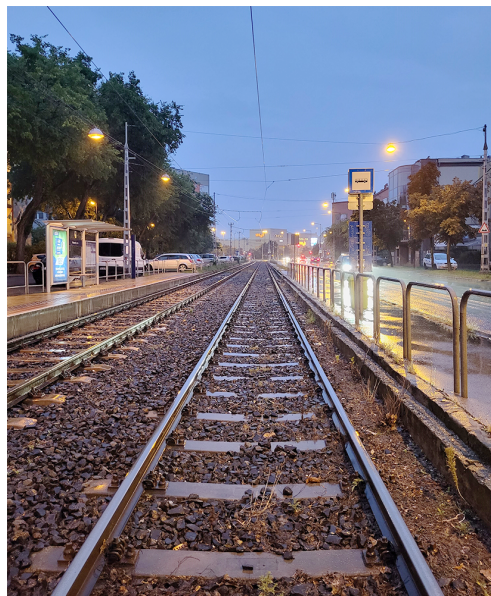
Fig. 1. The selected section – ballasted track (own photo)

last bed. There are five level crossings on the section, one has a high traffic load, and there is ESCRB III track system (Fig. 1).

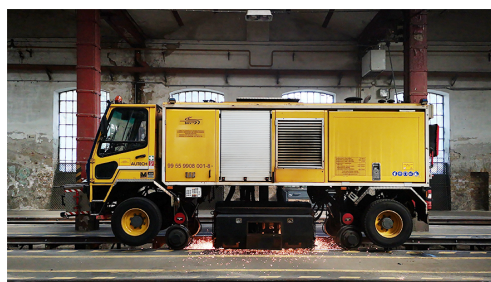
Fig. 2. Rail-grinding machine (own photo)

During the track section, the patrol walk observed that the rails' running surface has slight corrugation, and the appearance of defects in the rails is moderate. During the visual inspection, it was established that the railway operator applied a rail-grinding machine (Fig. 2) to extend the lifetime of the rails.

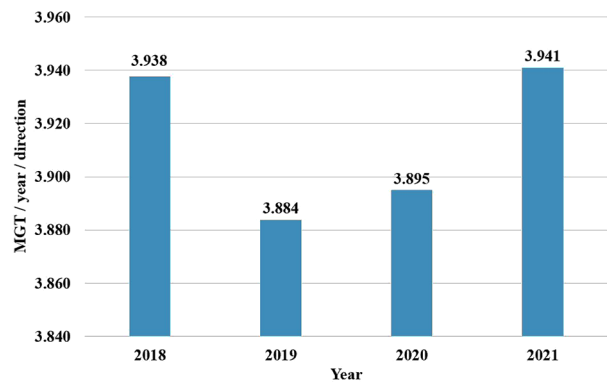
Fig. 3. Traffic load of the examined section in the last four years

Based on the calculation described above, the annual through-rolled tonnages of the examined line were calculated and classified into the traffic load class. Therefore, according to the calculations, it can be concluded that in the last four years, the traffic load of the line has been similar; it is a medium-loaded line (Fig. 3).

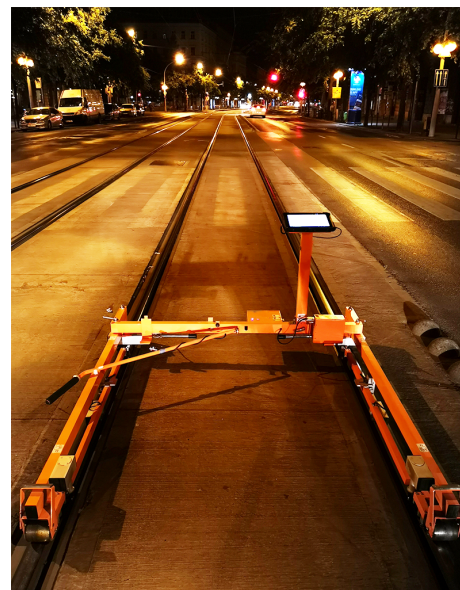
Fig. 4. TrackScan 4.01 instrument (own photo)

The TrackScan 4.01 instrument was developed and maintained by Metalelektro Mérés-technika Ltd (Fig. 4). This instrument was applied to measure track geometry characteristics on the tramway network of BKV PLC.

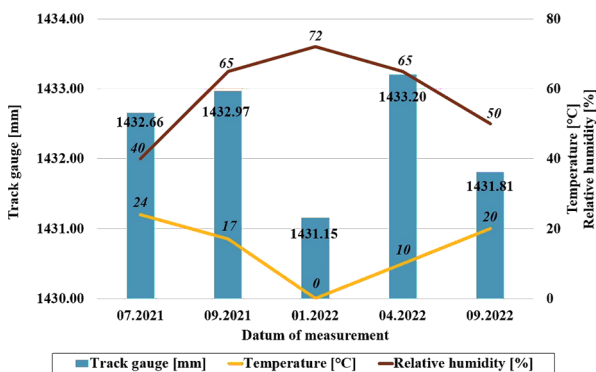
Fig. 5. Average values of the track gauge in the selected section

Fig. 5 shows that the average values of the measurement results change minimally concerning each other. Based on the evaluation of the measurement results in September 2021, the track had a minimal broadening of track gauge compared to the average value in April 2021. In January 2022, the average value of the track gauge parameter is less than in the case of the other four measurements. It can be assumed that the track gauge's narrowing at that time was due to the persistently cold weather. The average values of the measurement results in April 2022 are the highest, but it is important to note that in the days before the measurement, the average daily temperature rose permanently, and the number of hours of sunshine was also high. Although the average temperature in the week before September 2022 was 20 °C, the temperature decreased significantly from the beginning of the month, which may have resulted in a smaller average track gauge than the measurement in September 2021.

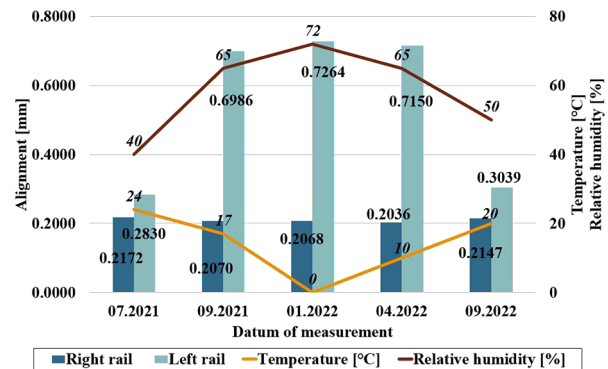
Fig. 6. Average values of the alignment in the selected section

Fig. 6 shows that the right rail's average alignment parameter remained almost the same during the measurement, but it changed significantly in the case of the left rail. The increasing value means that the horizontal deviation of the left rail increases inversely as the temperature decreases.

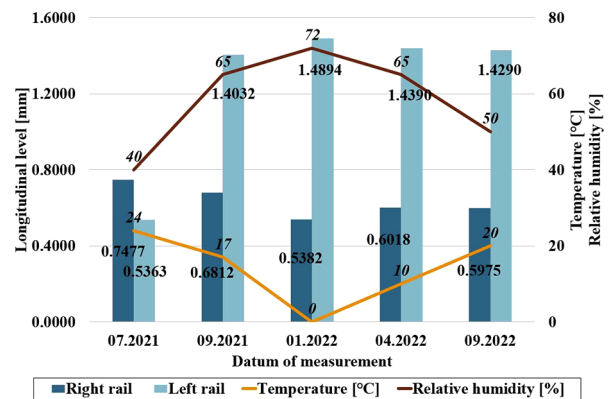
Fig. 7. Average values of the longitudinal level in the selected section

Fig. 7 shows that, similarly to the alignment parameter, in the case of the longitudinal level parameter, the deviation between the measurements in the right rail is minimal but significant in the left rail. Based on this, it is clear that when the weather is cooler, the vertical deviation of the left rail is more significant compared with the ideal than in the case of the right rail.

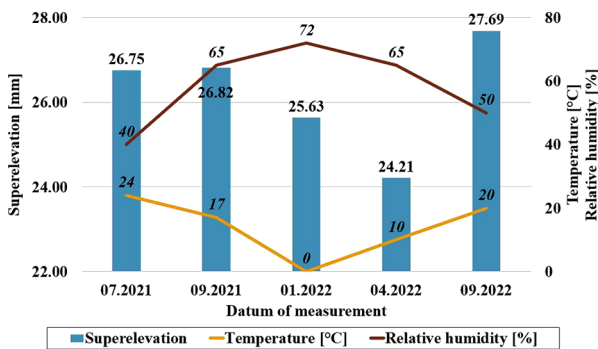
Fig. 8. Average values of the superelevation in the selected section

The deviation of the average values of the superelevation parameter is minimal between the measurements. As shown in Fig. 8, the value is the lowest for the measurement in April 2022, even though the lowest value would have been expected in January, considering the weather conditions. Therefore, based on the evaluation of the measurement results, the change in the average values of the superelevation parameter cannot be linked to the weather conditions.
